DEPARTMENT OF TRANSPORTATION

Quality Assurance and Source Inspection

Contract #: 04-0120F4Cty: SF/Ala Rte: 80 PM: 13.2/13.9File #: 69.28**WELDING INSPECTION REPORT****Resident Engineer:** Siegenthaler, Peter**Address:** 333 Burma Road**City:** Oakland, CA 94607**Report No:** WIR-017929**Date Inspected:** 31-Oct-2010**Project Name:** SAS Superstructure**OSM Arrival Time:** 1900**Prime Contractor:** American Bridge/Fluor Enterprises, a JV**OSM Departure Time:** 700**Contractor:** Zhenhua Port Machinery Company, Ltd (ZPMC), Changxing Island **Location:** Shanghai, China**CWI Name:** See below**CWI Present:** Yes No**Inspected CWI report:** Yes No N/A**Rod Oven in Use:** Yes No N/A**Electrode to specification:** Yes No N/A**Weld Procedures Followed:** Yes No N/A**Qualified Welders:** Yes No N/A**Verified Joint Fit-up:** Yes No N/A**Approved Drawings:** Yes No N/A**Approved WPS:** Yes No N/A**Delayed / Cancelled:** Yes No N/A**Bridge No:** 34-0006**Component:** Tower and OBG Components**Summary of Items Observed:**

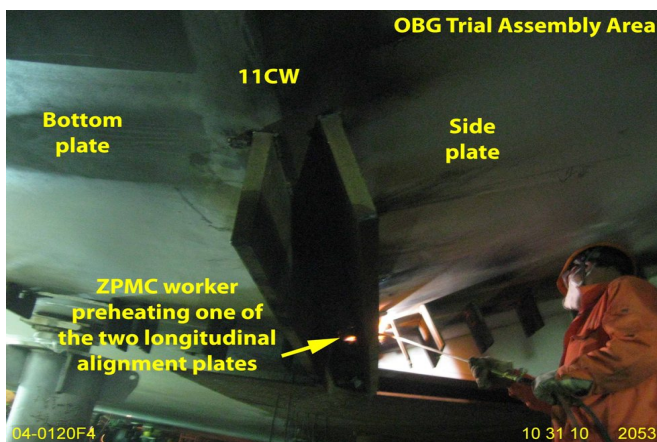
SMAW tack welding of temporary longitudinal alignment plates located on PCMK OBG 11CW/11DW, across transverse joint, one plate on each side of side plate to bottom plate longitudinal weld, south (crossbeam) side. See photo below. Welder was identified as 053475. QC was identified as ZPMC CWI Shi Lei (QC2). Welding variables recorded by QC2 appeared to comply with WPS-B-P-2214-FCM-1.
